Gunnison Basin Wet Meadow and Riparian Restoration and Resilience-Building Project

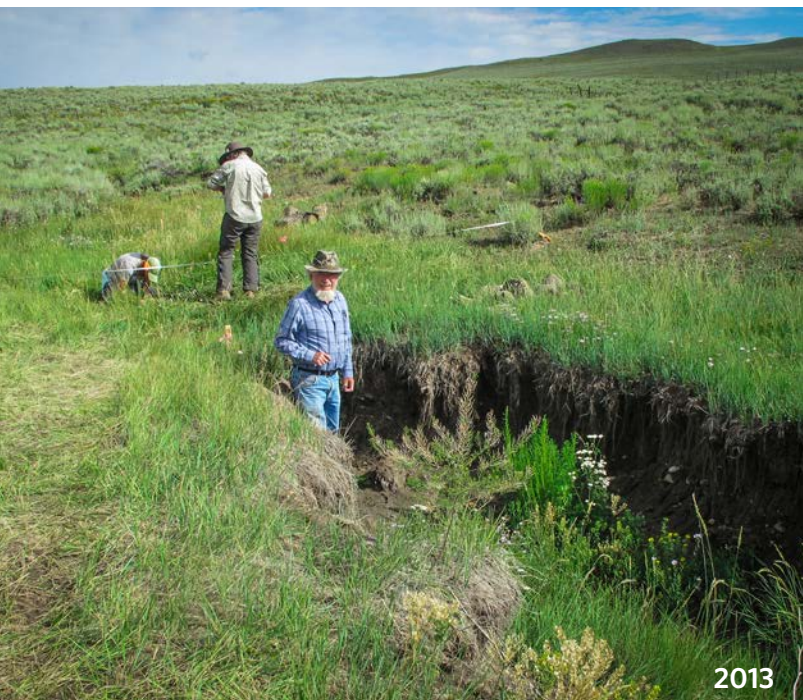
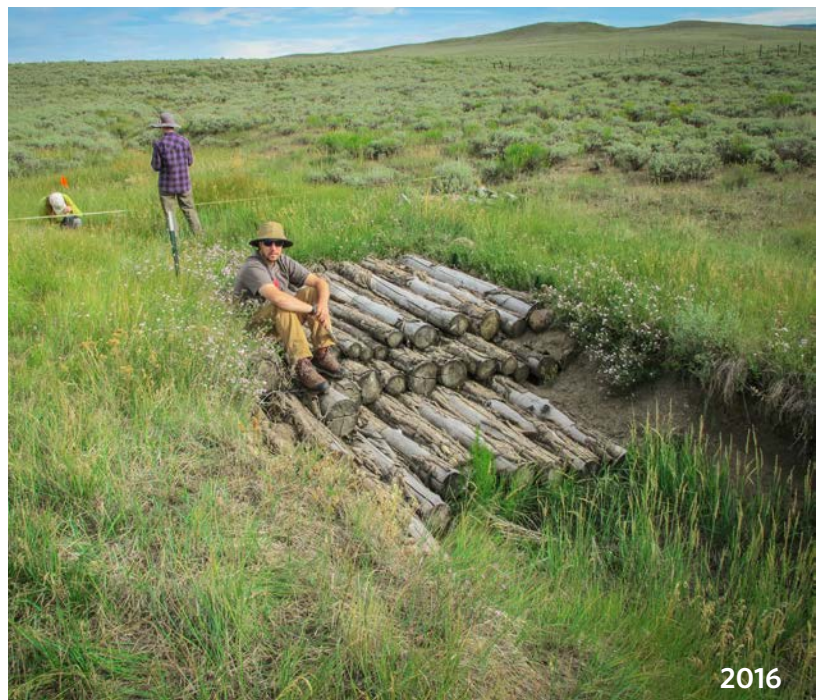
Left: Bill Zeedyk plans restoration work while standing in a head cut prior to treatment at West Flat Top Mountain, USFS;
Right: Completed log and fabric structure used to control the head cut post treatment. © Renée Rondeau/CNHP

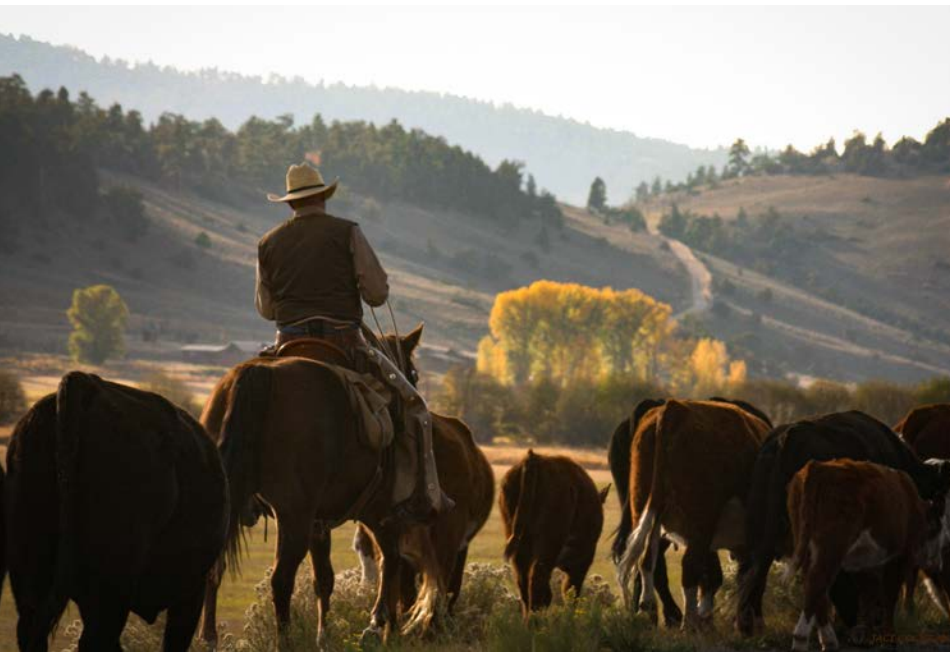
Between 2012-2016, the team restored approximately 140 acres with over 1,000 structures along 21 stream miles in eight watersheds, enhancing over 1,000 acres of Gunnison sage-grouse brood-rearing habitat. Crews also modified 100 previously installed rock structures, by adding a second layer, to improve their effectiveness.

Restoration techniques include grade control structures (one rock dam and low water crossing), flow dispersal structures (media luna, low water crossing, plug and spread, and filter dam) and headcut control structures (Zuni bowl, rock rundown, log and fabric, and layback). Most of the structures were hand-constructed with rocks, but several other techniques were used depending on site conditions and objectives. For example, the drift fence was used to reduce wildlife and cattle trailing in meadows. Field crews with Western Colorado Conservation Corps, Forest Service Youth Conservation Corps, and Wildlands Restoration Volunteers, as well as private contractors, helped build the structures.

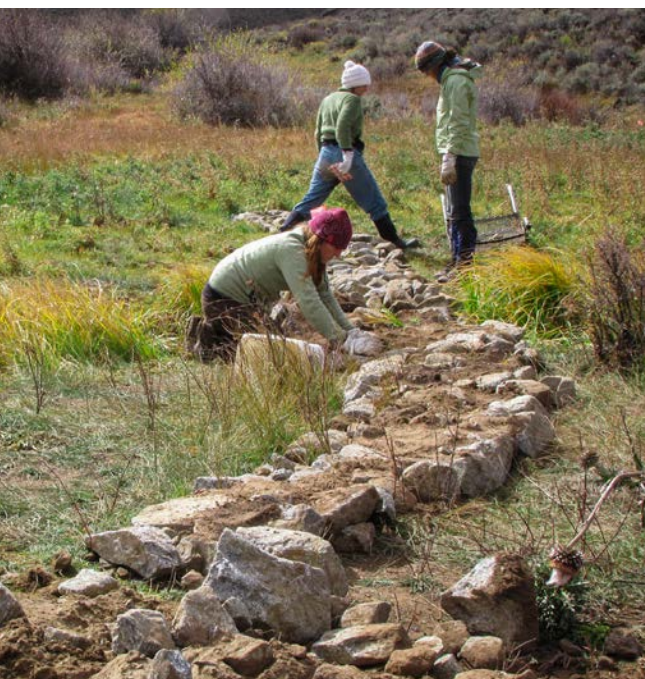
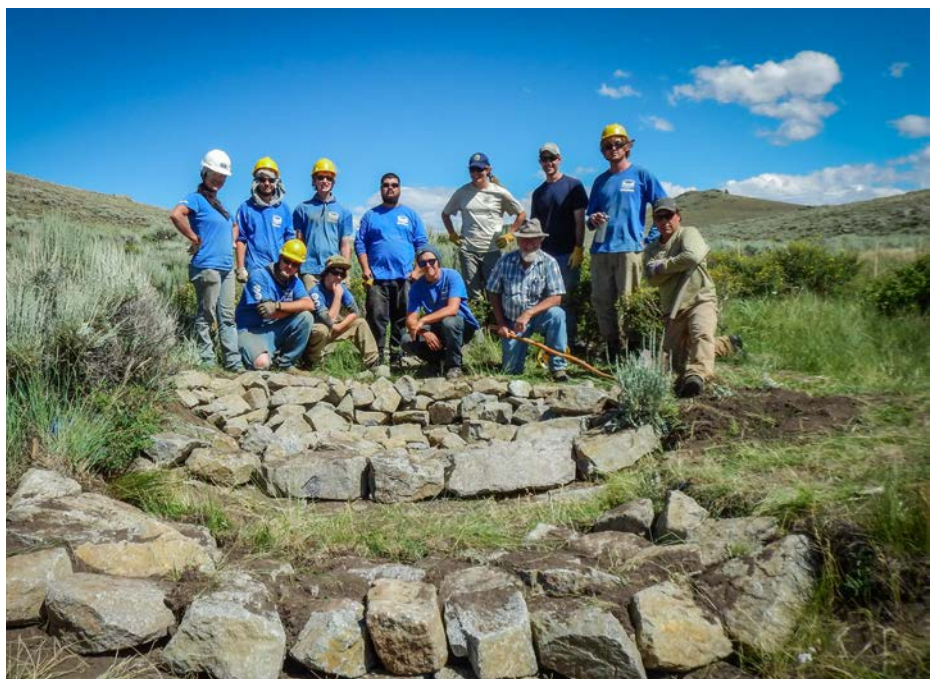
Clockwise from top: Jim Cochran moving cattle © Jaci Cochran, Western Colorado Conservation Corps field crew complete a Zuni bowl and one rock dam at Chance Gulch © Andrew Breibart, Volunteers building a media luna at CPW's Kaichen State Habitat Area © Claudia Strijek/WSCU

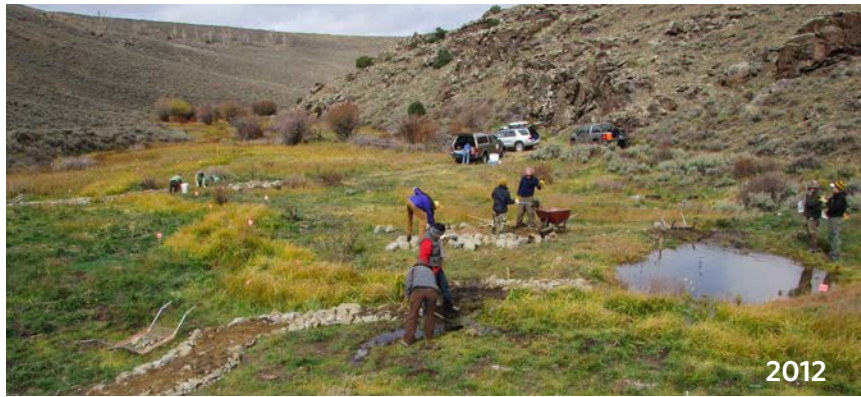
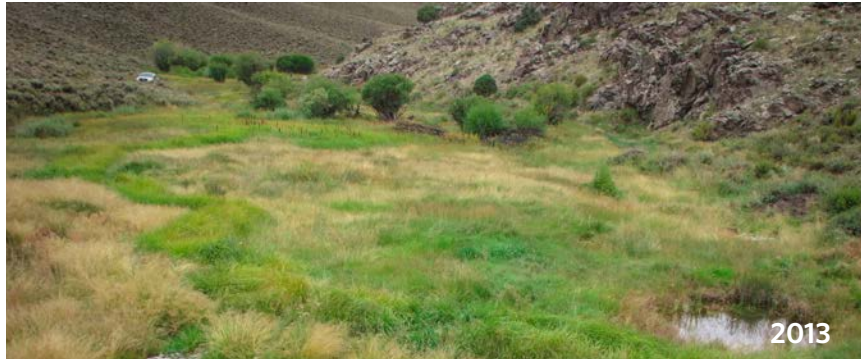
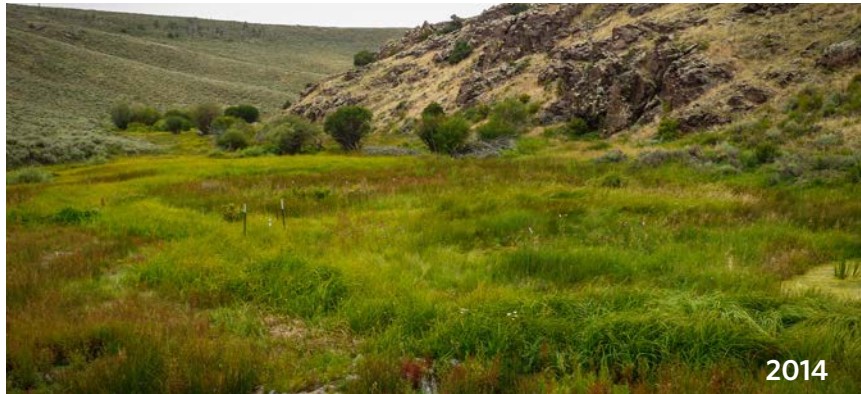
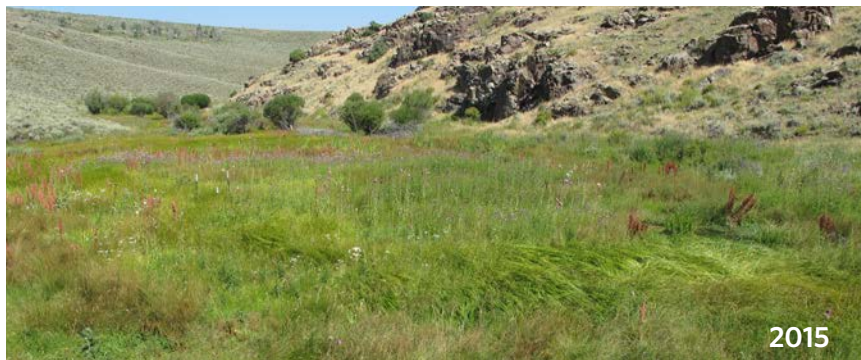
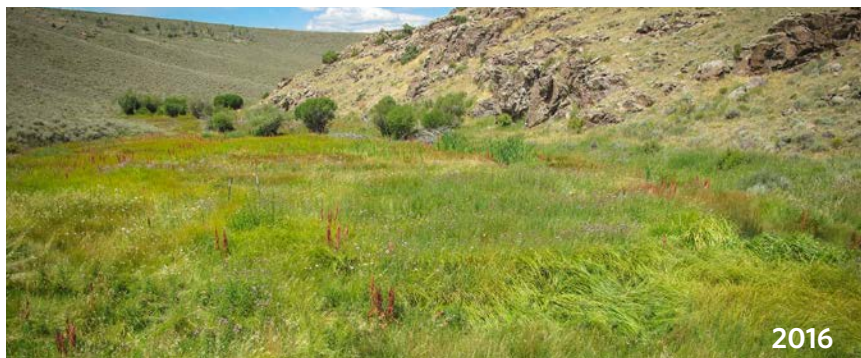
Wetland meadow vegetation response over five years to a media luna installation at Wolf Creek. Wetland area increased from 25% to 80% from 2012-2016.

Monitoring plant species cover is important to measure progress towards restoring wetland function (i.e., raise the water table, connect the water table to the floodplain). Because wetland plants indicate higher soil moisture and provide insect habitat and cover for sage-grouse chicks, the team measured wetland plant cover as an indicator of restoration success. Wetland species cover increased between 28-245%. Several factors are likely contributing to the variation in response rate: amount and timing of snowmelt, storm events, sediment load, geology, floodplain width, upstream stock ponds, degree of degradation and number of years post-treatment.

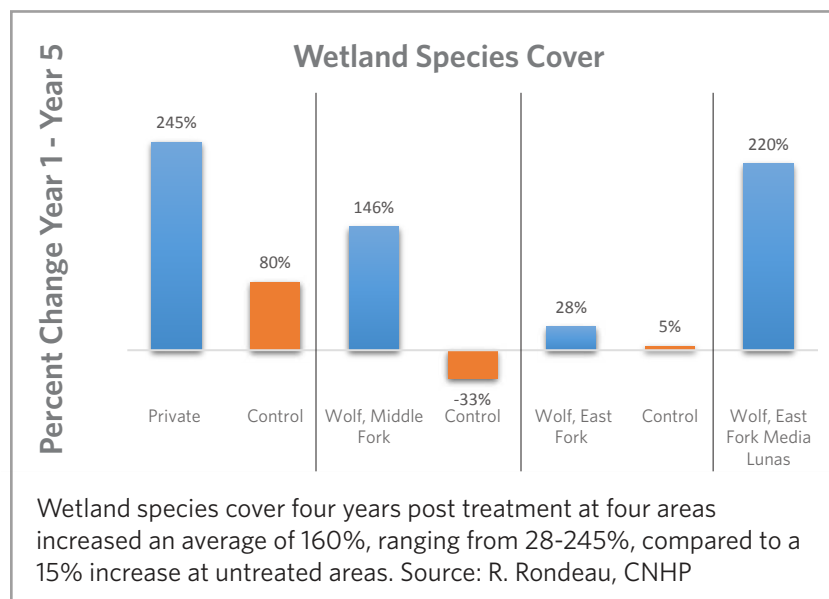
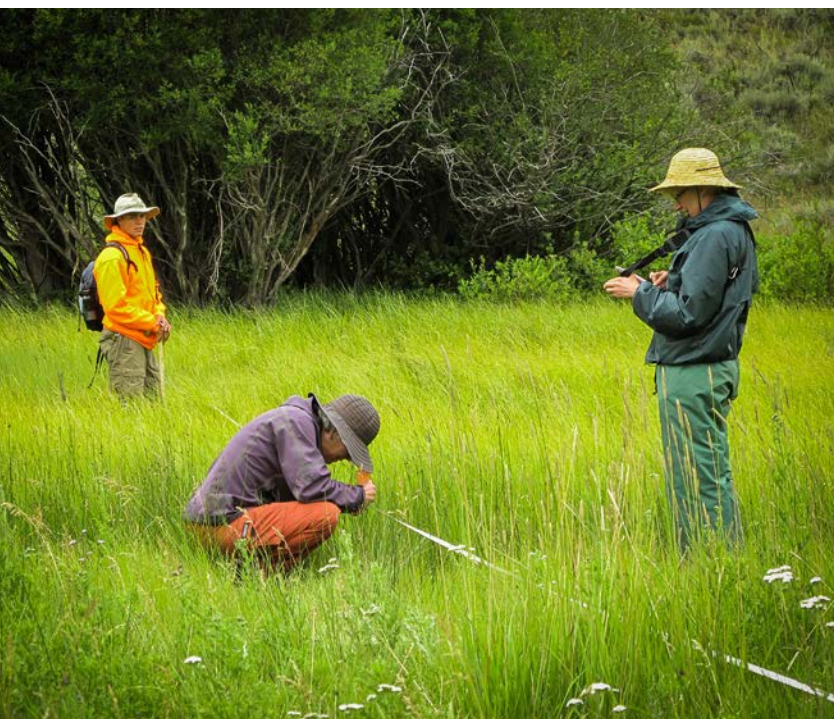
"Monitoring allows practitioners and funders to understand if their restoration efforts are producing positive results. By collecting vegetation data and before- and-after photographs, we determined that wetland species cover has increased at treated sites compared to untreated sites. It is critical to have untreated areas that are similar to treated areas to ensure that our comparisons are scientifically sound."
